US 64011504-05

Rocker Arm Prematurely Worn

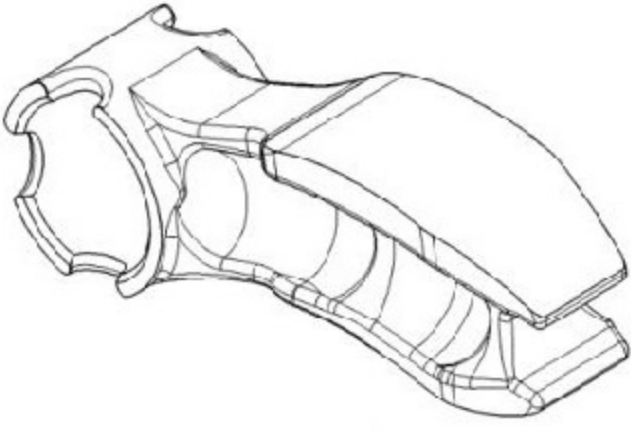
The coating of the new lever has additional layers, which have a damping effect and increase the robustness of the layers. Visually the new rocker arms differ considerably from the old ones, see attached image.

– New rocker arms

For all S-models (K46, K46/11, K46/12, K46/13, K47, K47/11, and K49) in a repair case, the new version rocker arms are to be installed. Also exchange ALL 16 rocker arms and both camshafts, engine oil and oil filter).

Order the following part number for the S-model rocker arms: 11 33 8 389 397.

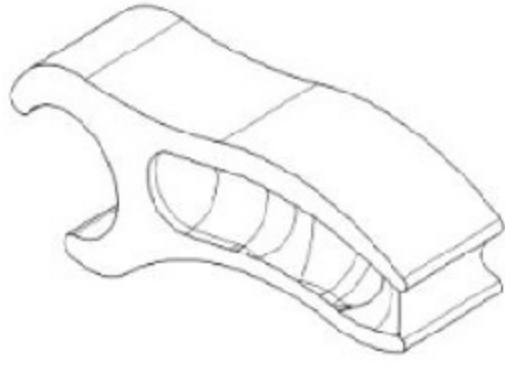
Until further notice, continue to install the original rocker arms in all K02 (G310R), K03 (G310GS), K5x (R1200's) and K8x (F850/750GS) motorcycles.

– Current rocker arms all other models

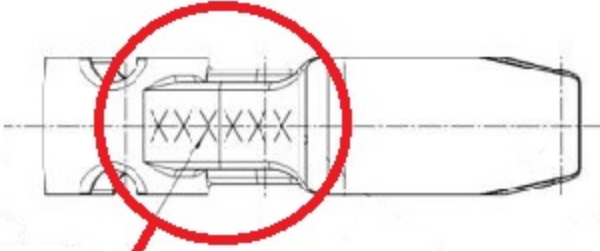
Batch Number

If problems re-occur with the new rocker arms, please inform us immediately using a TSARA case with informative photos, in which the batch numbers of the rocker arms (see attachment for batch number location) and the complaints are visible.
