## Body Repairs - Water Leaks - Water Leak

Diagnosis and Testing

### Water Leak Diagnostic Procedure

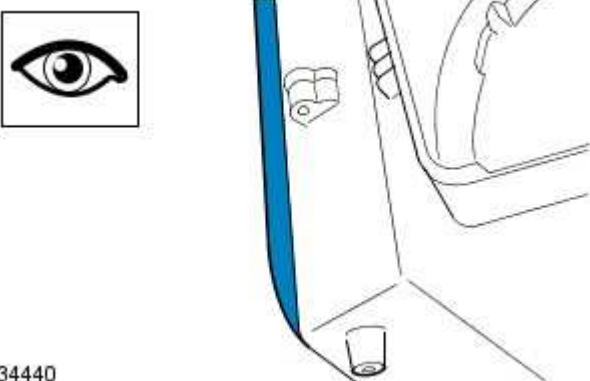
**PINPOINT TEST H : AIR INTAKE DUCT TO BLOWER**

TEST CONDITIONS	DETAILS/RESULTS/ACTIONS
<b>H1: AIR INTAKE DUCT TO BLOWER</b>	
<ul style="list-style-type: none"> <li>NOTE: The wing install process is to lower the wing into place along the face of the scuttle panel, this can displace the foam seal attached to the blower box</li> </ul>

<p>E134440</p>	<ol style="list-style-type: none"> <li>1 Check the condition and location of the foam gasket joint between the air intake duct, and the blower box installed to the scuttle panel</li> </ol>
	<ol style="list-style-type: none"> <li>2 If possible apply sealant to the aperture with the wing installed</li> <li>3 If it is not possible to seal the aperture with the wing installed, remove the wing to complete the repair</li> <li>4 Materials required: sealant (clear/body coloured), gloves, spirit wipe, cloth</li> <li>5 Allow the sealant to cure, and retest suspect area for water entry</li> </ol> <p>Is water still entering the vehicle?</p> <p><b>Yes</b> Carry out a water leak test and visual inspection of any suspect or wet areas, once the water entry point has been determined refer to the "Water Ingress Paths And Recommended Repair Procedure" above</p> <p><b>No</b> Reinstall any trim/panels or component that have been displaced</p>

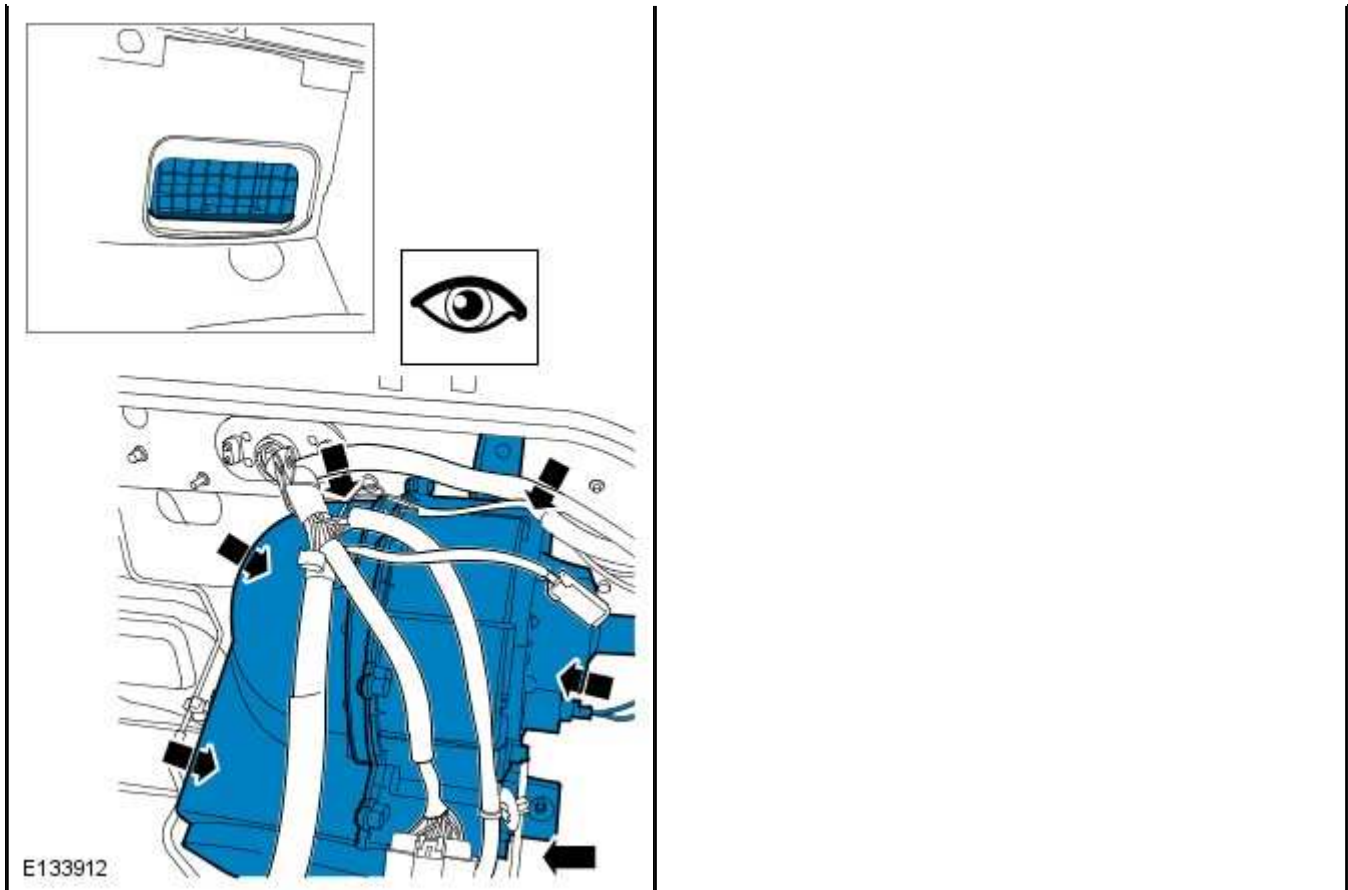
- 3** On some 07 model year vehicles there may be water actually dripping through the blower box grille in the passenger footwell, this is caused by a problem with the sealing of the two halves of the blower box itself, and replacement of the blower box is recommended

- 2** If it is not possible to highlight the actual area of the ingress the remove the blower box and check the integrity of the foam gasket, replace gasket as required, adding a fine bead of sealant to the gasket before carefully reinstalling to ensure a good seal

- 4** Materials required: sealant (clear/body coloured), gloves, spirit wipe, cloth, replacement gasket, blower box
  - 5** Allow the sealant to cure, and retest suspect area for water entry

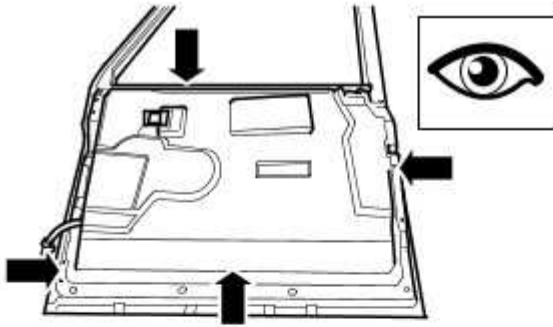
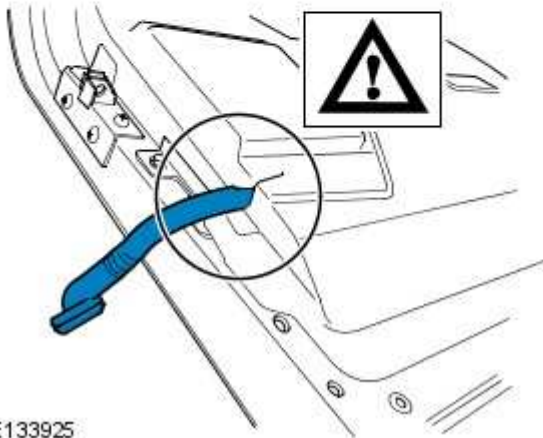
**2** Check the condition of the flip seal at the bottom of the door if damaged or misaligned may allow water ingress

**3** Materials required: "paint" roller, sealant, dum-dum

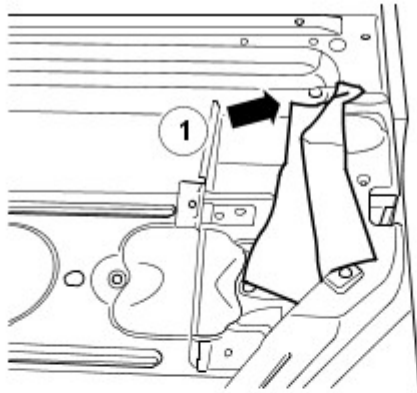
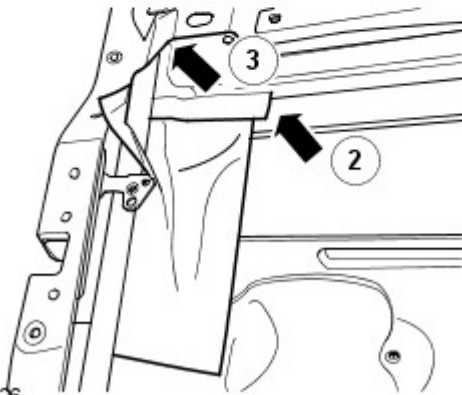
TEST CONDITIONS	DETAILS/RESULTS/ACTIONS
<b>O1: DOOR LATCH/DOOR EDGE</b>	
<ul style="list-style-type: none"> <li>NOTE: Water leak path is visible down the edge of the door and into the A post/footwell/sill area of the vehicle</li> </ul>	<ul style="list-style-type: none"> <li>NOTE: Use of a mirror and torch will assist</li> </ul>
	<p><b>1</b> Remove the door casing. Remove the door shedder to gain access to the latch mechanism. Check along the top of the latch shedder for damage/poor adhesion (Fig 1)</p>

- 2** Apply sealant / dum-dum along the top of the latch shedder (fig 2)
- 3** Apply sealant to the panel joints above the latch shedder but underneath the glass run channel (Fig 3)
- 4** Materials required: sealant, dum-dum, tools (for door casing removal), **door shedder – must be replaced**
- 5** Allow the sealant to cure, and retest suspect area for water entry

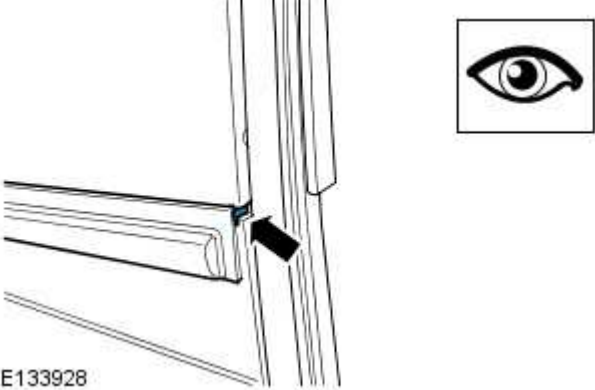
TEST CONDITIONS	DETAILS/RESULTS/ACTIONS
<b>P1: REAR TUB CAPPING</b>	
<ul style="list-style-type: none"> <li>• NOTE: Whilst it is not necessary to remove the door aperture seal to complete this repair, care must be taken to ensure the repair seals any gaps up to and including the joint seal</li> </ul>	
	<ul style="list-style-type: none"> <li><b>1</b> Apply small bead of sealant or dum-dum into the capping to body side joint (as arrow indicates)</li> </ul>

<p>E133928</p>	
	<p><b>2 Critical visual area = high quality of sealant finish required</b></p> <p><b>3</b> Materials required: sealant, dum-dum</p> <p><b>4</b> Allow the sealant to cure, and retest suspect area for water entry</p> <p>Is water still entering the vehicle?</p> <p><b>Yes</b> Carry out a water leak test and visual inspection of any suspect or wet areas, once the water entry point has been determined refer to the "Water Ingress Paths And Recommended Repair Procedure" above</p> <p><b>No</b> Reinstall any trim/panels or component that have been displaced</p>

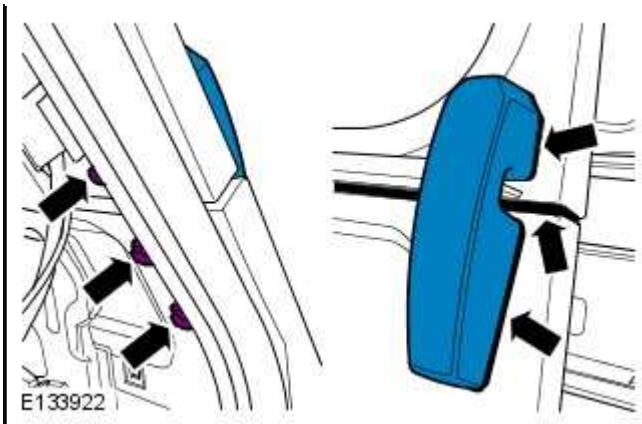
• NOTE: For pre-2009MY vehicles or if there was a significant leak around this area, it may be pertinent to apply sealant along the scuttle panel to windscreen casting join prior to reinstalling the hinge

- 1** From inside the vehicle undo the 3 fixings that hold the windscreen hinge in place. Remove the hinge from the vehicle. Remove the existing gasket and any residue of adhesives or sealant. Re-fit the hinge gasket. Apply a small amount of sealant around each fixing hole

<b>2</b>	Materials required: sealant, windscreen hinge gasket
<b>3</b>	Allow the sealant to cure, and retest suspect area for water entry
Is water still entering the vehicle?	
<b>Yes</b>	
Carry out a water leak test and visual inspection of any suspect or wet areas, once the water entry point has been determined refer to the "Water Ingress Paths And Recommended Repair Procedure" above	
<b>No</b>	
Reinstall any trim/panels or component that have been displaced

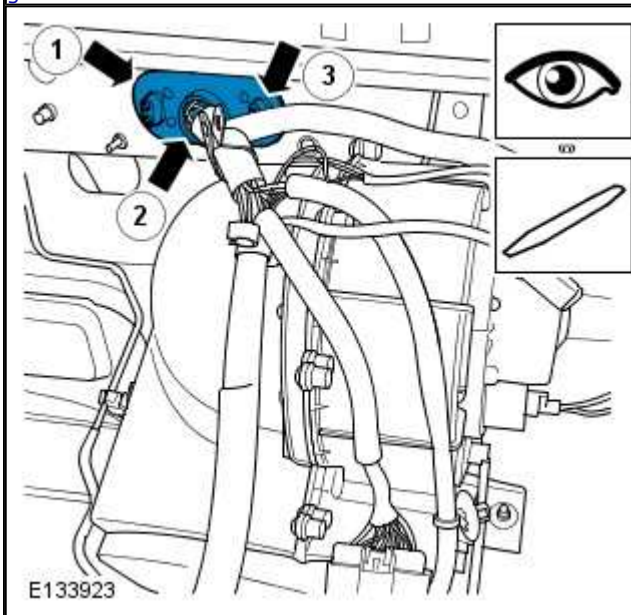
- NOTE: Visually inspect the grommet looking for areas of poor seating
- NOTE: Inspect the "U" channel to skuttle panel for distortion between spot welds allowing water to seep onto the grommet

<b>1</b>	Use a boning tool to re-seat the grommet. Additional sealant should be applied around the outer edges of the grommet and the body panel
<b>2</b>	On occasions it maybe necessary to seal the main harness collar in addition to outer grommet. This will be evident during re-test
<b>3</b>	Materials required: sealant, boning tool
<b>4</b>	Allow the sealant to cure, and retest suspect area for water entry
Is water still entering the vehicle?	
<b>Yes</b>

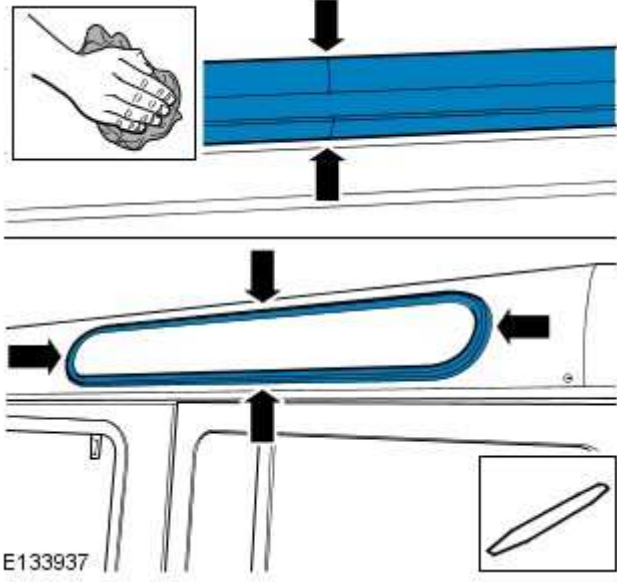
PINPOINT TEST AC : ALPINE LIGHTS	
TEST CONDITIONS	DETAILS/RESULTS/ACTIONS
<b>AC1: ALPINE LIGHTS</b>	
<ul style="list-style-type: none"> <li>NOTE: High visibility area excess sealant must be wiped away leaving no residue or evidence of repair</li> </ul>

<p>seal this is a very rare leak path. The leak is probably caused by deformation to the gasket which should be evident by visual check. The gasket should be re-seated and re-tested prior to completing this repair. Using the boning tool carefully lift the outer edge of the gasket seal. Working around the alpine light, lift and apply sealant between the gasket and the roof panel. Care <b>must</b> be taken to ensure that the roof is not damaged or scratched whilst sealing the alpine light</p>
	<p><b>3</b> For leaks through the centre (lace section) apply sealant between the joint and wipe away an excess sealant</p>
	<p><b>4</b> Materials required: sealant (clear/black), boning tool, cloths, spirit wipe, gloves</p>
	<p><b>5</b> Allow the sealant to cure, and retest suspect area for water entry</p>
	<p>Is water still entering the vehicle?  <b>Yes</b>          Carry out a water leak test and visual inspection of any suspect or wet areas, once the water entry point has been determined refer to the "Water Ingress Paths And Recommended Repair Procedure" above  <b>No</b>          Reinstall any trim/panels or component that have been displaced</p>

<p><b>1</b> <b>Gasket joint leaks</b> - Using black sealant, seal between the joint edges of the gasket</p>
	<p><b>2</b> <b>Gasket to roof leaks</b> - Due to the design of the gasket</p>
